Kemsing St Mary the Virgin

The conservation of the 13th century stained glass
in the south aisle window sV (CVMA numbering)

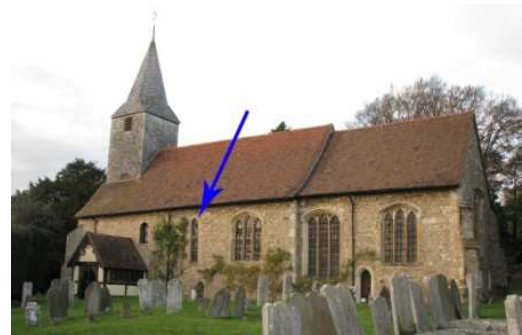
St Mary's Church from the south, with location of window sV

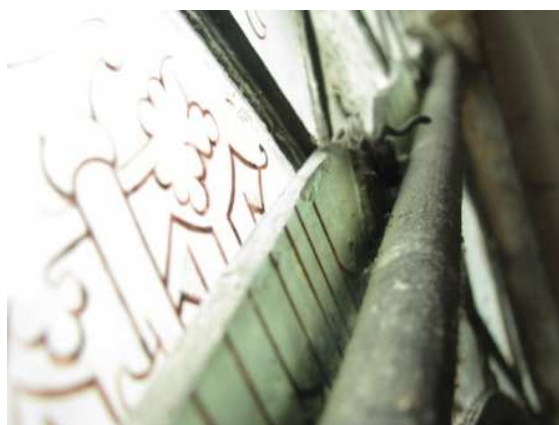
The crudely chopped upper edge of the internal panel. Note the two layers are touching.

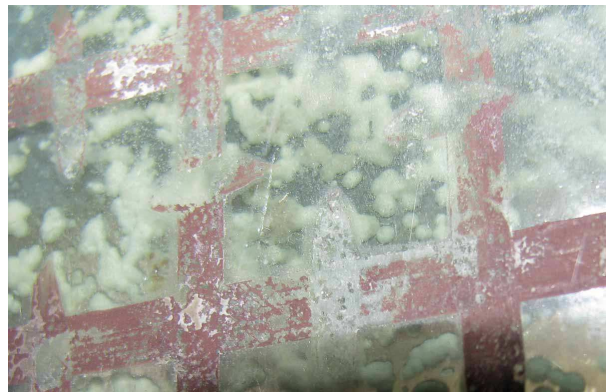
Close-up of internal surface, paint loss and glass corrosion. External corrosion pits can be seen through the glass.

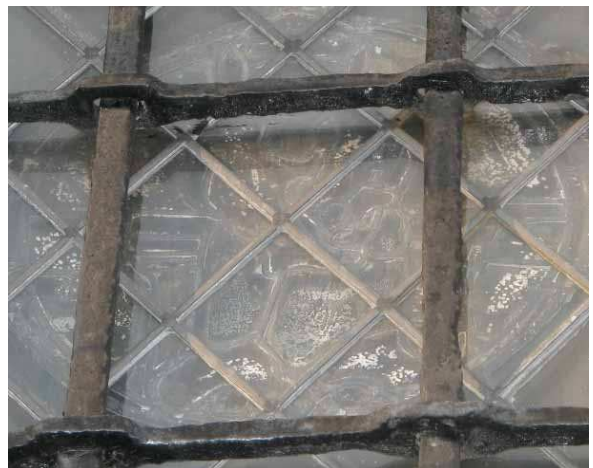
External surface with white corrosion deposits.

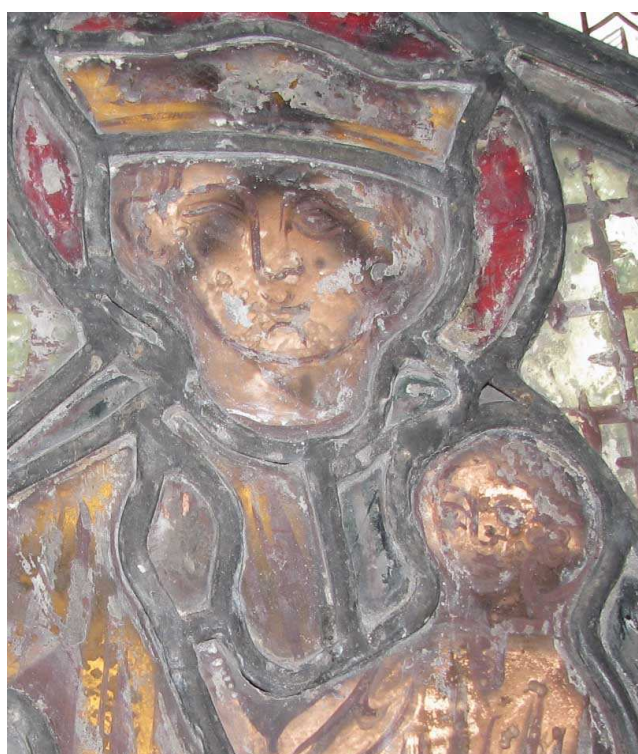
Surface accretions on the inside

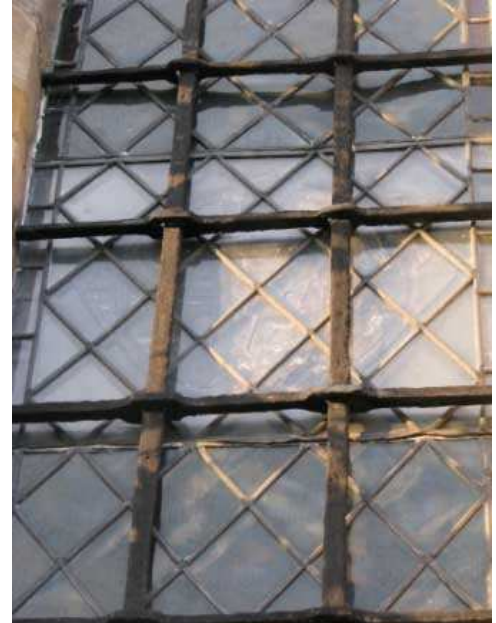
Window sV showing reflective surface of the current protective glazing.

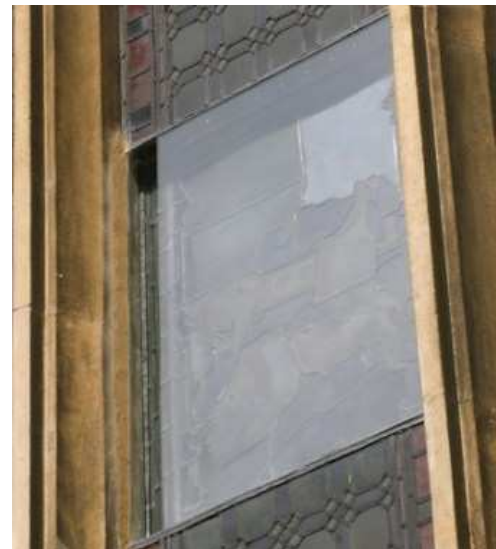
St Peter's Church, South Weald, external protection of 17th century stained glass, installed in 2007. 6.4mm laminate safety glass.

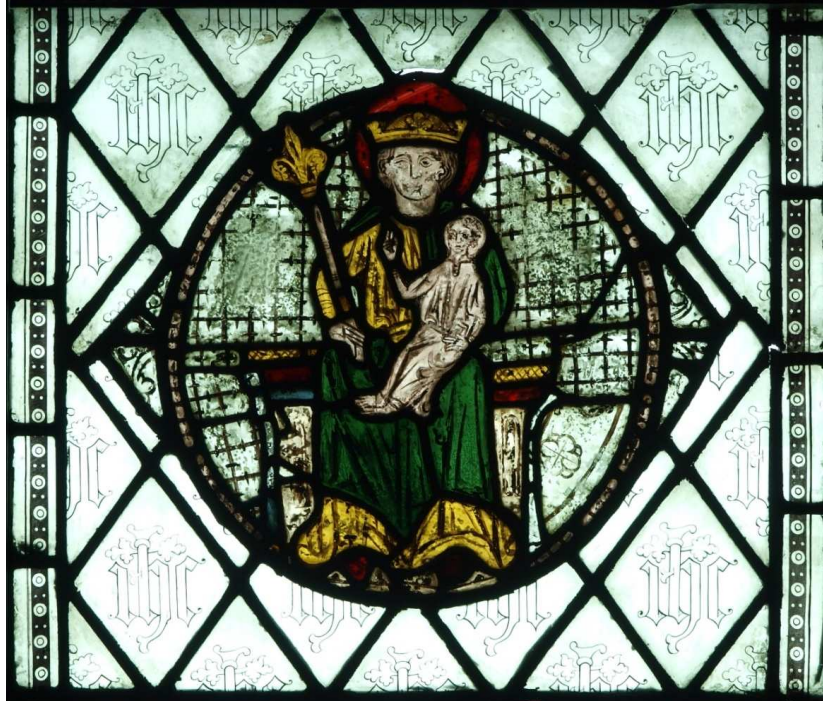
The historic glass should be framed in a bronze channel frame and re-set onto the inner edge of the stone reveal, thus creating a larger interspace of at least 40mm. A ventilation gap at the top and at the bottom of this panel will ensure a constant air exchange in the interspace, thus keeping the historic stained glass closer to the internal air temperature. Please refer to the sketch on plate 3 for the technical specification.
